# スペイン国立装飾美術館所蔵山水人物蒔絵筆筥 [ 修理報告 ]

著者	松本 達弥
図書名	在外日本古美術品保存修復協力事業 : 修理報告書 : 絵画 / 工芸品[平成18年度実施事業] : The Cooperative Program for the Conservation of Japanese Art Objects Overseas
開始ページ	183
終了ページ	197
出版年月日	2008-03-31
URL	<a href="http://id.nii.ac.jp/1440/00005512/">http://id.nii.ac.jp/1440/00005512/</a>

山水人物蒔絵箆笥 (スペイン国立装飾美術館)

*Makie Decoration Cabinet with Landscape and Human*  
(Museo Nacional de Artes Decorativas)

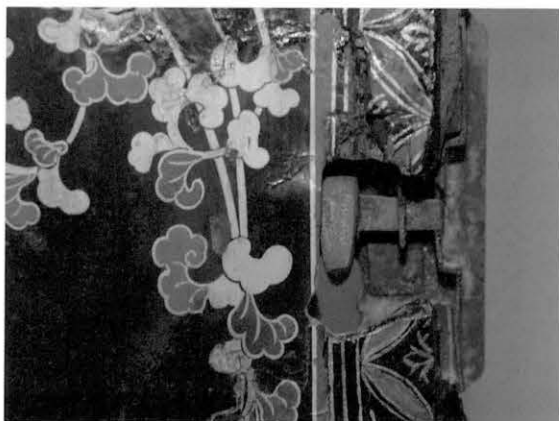
- ・箆筒の内外全体には、後補の塗料が塗られ全体が黒ずんで見える。
- ・正面扉の文様は擦れて欠失した部分が多く、特に高蒔絵部分は欠損が多い。
- ・両扉の端喰部分や素地の接ぎ目と思われる部分の内外に、亀裂が入っている。(図12.14)
- ・正面扉の左右6個の蝶番は後補であり、蝶番下の塗膜には制作当初の釘穴が確認できる。(図11.25)
- ・正面右下の隅金具は後補であり、残り3ヶ所の隅金具は付いていない。
- ・両側面の天板角部分の塗膜は欠損が多く素地が露出し、周辺塗膜は剥離し剥落の恐れのある危険な状態である。(図13)
- ・天板部分の文様は擦れて欠失しているが、文様の置目や高上した下地の形跡が確認できる。
- ・右側面の天板と側面板の素地接合部や端喰部分に亀裂がある。
- ・右側面の伏彩色された螺鈿は剥離、剥落があり、欠失した部分には伏彩色の塗料が露出している。(図8)

図 12 扉裏 損傷部分

Fig. 12 Inner side of the door panel, damaged part

- There were cracks around the joints of the substrates of the left and right door panels (Figs. 12, 14).
- The six hinges on the left and right doors were later additions, and nail holes belonging to the time of original manufacture were observed on the coating film underneath the hinges (Figs. 11, 25).

本資料の左右扉には、素地の接合部に亀裂が多くあり、一部は鉄釘で補強されている箇所があった。圧着に使用する接着剤は、グルテンの量が多い小麦粉を水練りし、生正味漆を練り合わせた麦漆を使用した。圧着は、端金やクランプを使用し作業を行った。(図 21. 22)

There were many cracks on the joints of the substrate of the left and right door panels of the Cabinet, and in some places iron nails had been used for reinforcement. *Mugiurushi* (raw urushi mixed with flour having a high gluten content that had been kneaded with water) was used as an adhesive. Bar clamps and clamps were used for press stabilizing (Figs. 21, 22).

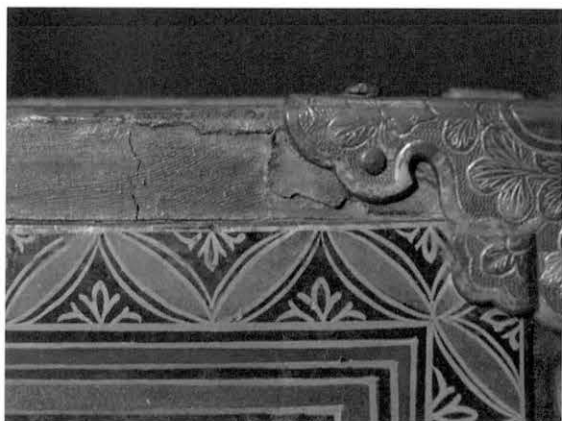
図 13 金具周辺 塗膜損傷部分

Fig. 13 Area around a metal fitting, damaged coating film

- The front lower right corner metal fitting is a later addition; there were no corner metal fittings on the other three lower corners.
- Much of the coating film at the junction of the top and side panels was missing and the substrate had become exposed. The surrounding coating film had become lifted and there was a great risk of further losses (Fig. 13).

亀裂部分の戻しきれない隙間や塗膜の欠損部分には、麦漆に楠材の木粉や麻の繊維を混ぜ合わせ、珪藻土を焼いた地の粉を加えた刻苧を形状が整うまで数回充填し復元を行った。なお、本資料の時代性や周辺塗膜の損傷が烈しいため、刻苧の充填は必要最小限に止めた。形状復元した部分は、砥石や鑢で刻苧肌を整えた。(図 26, 27)

*Kokuso* was used to fill the gaps on the cracks that could not be rejoined and the missing areas of the coating film. It was applied several times until the desired shape was obtained. *Kokuso* was made by mixing sawdust and hemp fibers to *mugiurushi* and adding *jinoko*, or baked diatomaceous earth. Since the overall atmosphere created by the passage of time and the coating film around the cracks and the missing areas were severely damaged, application of *kokuso* was kept at a minimum (Figs. 26, 27).

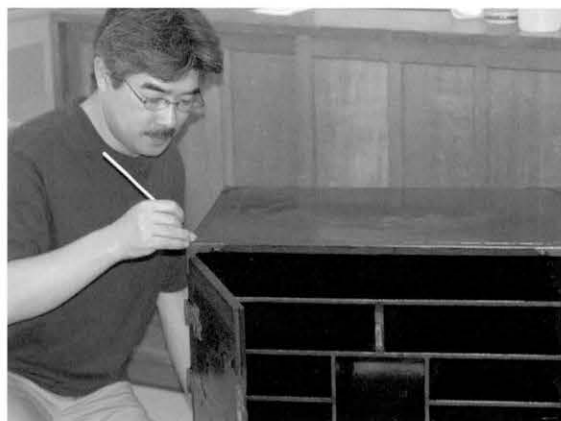
図 15 塗膜剥離部分 仮止め養生

Fig. 15 Facing the lifted coating film

本資料の亀裂部分の塗膜周辺は、作業中剥落しそうな危険な状態にあるため、細かく切った雁皮紙を糊貼りし塗膜の剥落防止を行った。（図 15. 16）

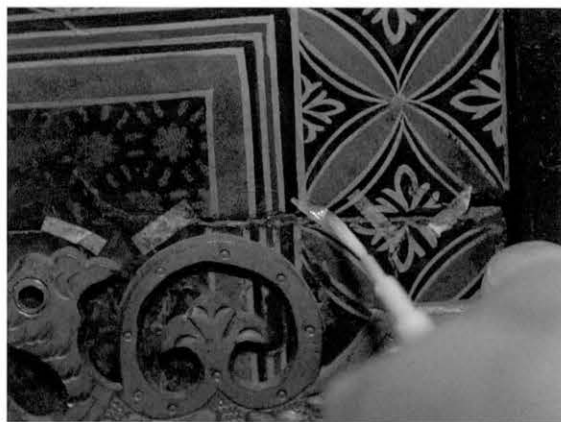
図 16 亀裂部分 仮止め養生

Fig. 16 Facing the cracks

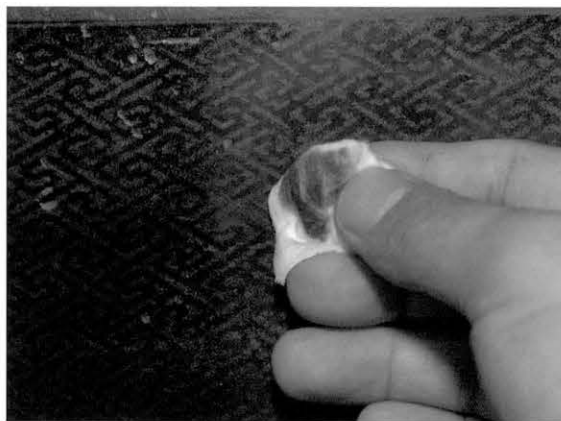
図 17 表面塗膜に塗られた塗料除去

Fig. 17 Removing the coating material from the surface of the coating film

本資料の漆塗膜は、紫外線や経年劣化により艶の無くなった塗膜の復元の為、数回塗料が塗られていた。また、亀裂部分や塗膜の損傷部分にも塗料が充填されており、このままでは漆による修復が困難になる為、塗料の除去が必要になった。

図 18 表面塗膜に付けられた塗料除去

Fig. 18 Removing the coating material from the surface of the coating film

図 19 塗料除去 (左 除去前、右 除去後)

Fig. 19 Removal of the coating material (left: before removal, right: after removal)

Some coating material had been applied several times to the Cabinet in order to reproduce the original urushi coating film that had lost luster due to ultraviolet rays and the passage of time. Cracks were filled and damaged coating film was impregnated with the same material. Since it would have been difficult in such a condition to use urushi for restoration, it became necessary to remove this coating material. After testing several types of solvents, it was found that a weak solvent would not be effective in removing the coating material. Thus, a slightly strong solvent, Tetra-Hydrofuran (THF) was used. It was applied to the surface of the coating material with a small brush. Once the coating material had become soft, it was removed by using a cotton cloth moistened with ethanol. Where the coating material had been applied thickly, a spatula or a knife was used to carefully scrape off the softened coating material, making sure not to damage the urushi coating film. It took approximately 10 months to completely remove the coating material from the Cabinet (Figs. 17 – 19).

塗料除去には、数種類の溶剤を試した結果、弱い溶剤では反応がなく、少し強い溶剤であるテトラヒドロフラン (THF) にて除去を行った。除去は、テトラヒドロフランを筆に含ませ塗料面に塗布し、塗料が軟化した後、エタノールで残った塗料を綿布にて拭き取った。なお、厚みのある塗料は、溶剤で軟化した塗料を篋や刃物で漆塗膜を傷付けないよう細心の注意を払い除去した。本資料全体の塗料を除去するには、約 10 ヶ月の期間を要した。(図 17~19)
